## ET10: การวิเคราะห์สภาวะการผลิตของหอกลั่นสารอะโรมาติกส์ ด้วยเทคนิคการส่งผ่านรังสีแกมมา

## GAMMA TRANSMISSION TECHNIQUE TO INVESTIGATE THE AROMATICS DISTILLATION PROCESSES.

In the technical Cooperation between PTTAR and TINT during 2007-2009, problem shooting process investigation of the 34 Aromatics production units, mainly distillation columns, was conducted by gamma transmission technique during plant on-line production. In common practice, a collimated 50mCi Cobalt-60 gamma radiation source and a collimated NaI (TI) scintillation detector were set at the same horizontally alignment, opposite and along side the vessel and were then simultaneously vertically moved to several selected elevations. Transmitted gamma intensity penetrating through the vessel at each elevation was recorded and was plotted against the elevation. In comparison with engineering drawing of the vessel, status of process behavior and/or physical abnormality of internals such as foaming, flooding, blockage, damaged etc. could be indentified. This nuclear technology has been recognized as one of the powerful tools for management and planning of production and preventive maintenance program.

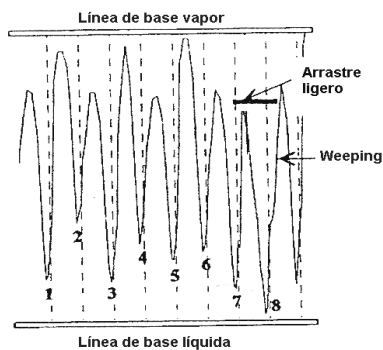
## 4 – Scanning profile through the down comers:

The detected radiation intensity is lower under even trays (2, 4, 6) than under the odd trays. The scan of even trays partially crosses the down comers and the signals are absorbed more. A bad separation liquid/vapor is observed between the trays 7 and 8. This means that slight liquid entrainment from tray 8 to tray 7.

The liquid level on the tray 8 is higher. Liquid weeping is visible at the tray 8.

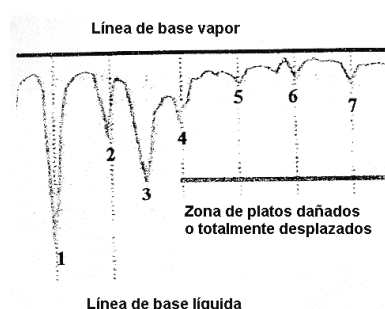
## 5 – Normal, displaced and missing trays

Tray 1 is intact and holds liquid.

Tray 2 holds relative small amount of liquid and is partially damaged.

Tray 3 is intact but slight flooding is observed.

Tray 4 is partially damaged. Trays 5, 6 and 7 are totally damaged and are displaced.

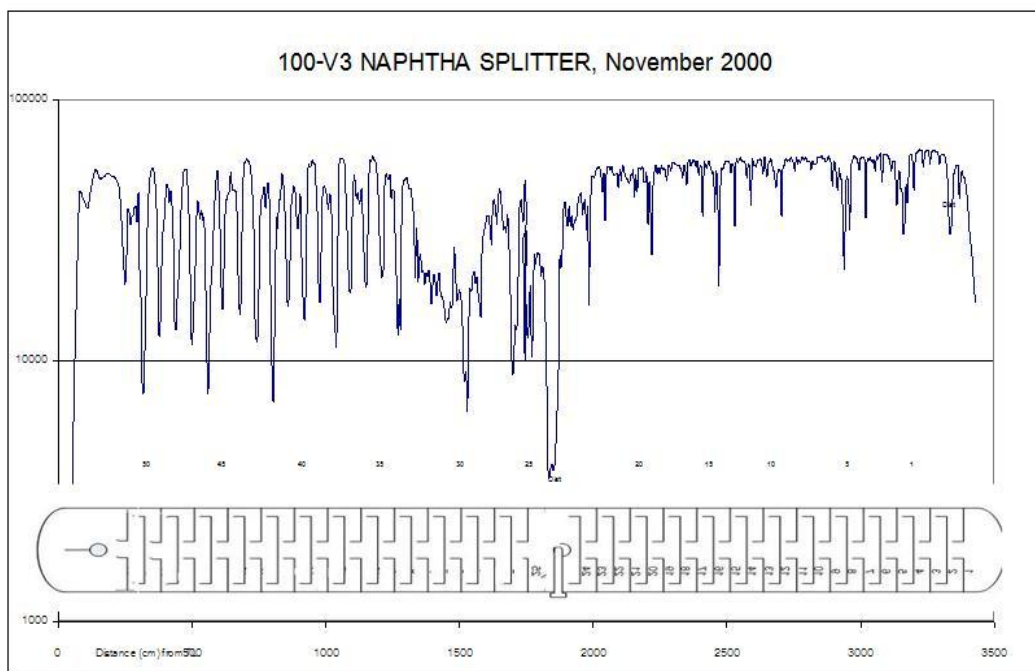
firstly inspected in November 2000 and it was observed from the relative gamma intensity-distance profile presented in figure 2 that most trays in top section (tray 1 to tray 24) were damaged. Tray debris fell on lower trays causing blockage and liquid flooding accumulating from tray 33 through liquid distributor to tray 24. Tray 34 to tray 50 had good definition with liquid loading and clear vapor spacing. Slight regular reducing of vapor count rates below even tray was normal as the scan line slightly intersected down-comers of those even trays. High absorption peaks at tray 50, 46, 42, 38, and 34 was due to effect of external rings only. The vessel was immediately shutdown for maintenance and trays damage/collapsed was visually confirmed as shown in figure 3. As the problems was identified in advance the shutdown for maintenance could be shorten thus saving huge economical losses. During plant debottlenecking program in 2006, the 100-V3 was modified with special designed trays in the lower section. The odd and even trays have 90° rotated down comers as shown in figure 4. Right after modification, the vessel was inspected and flooding in the lower section was observed in January 2007 (figure 5). Routine inspection of this vessel was carried out as the annual basis for process optimization and the last result obtained in February 2009 represented the normal operating/optimized column. It was clearly observed that regular pattern of gamma intensity when passing and not passing each adjacent even-odd tray down comer. (figure 6).

Figure 2 Tray damaged & Collapsed in the upper section of 100-V3 (November 2000)

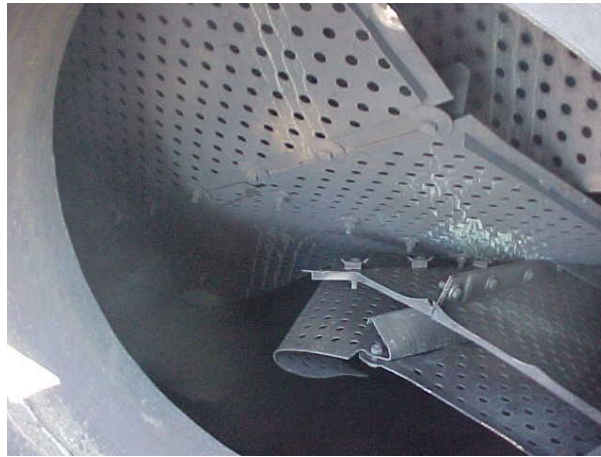
Figure 3 Tray damaged and collapsed from upper section to middle section of 100-V3 (Nov. 2000)

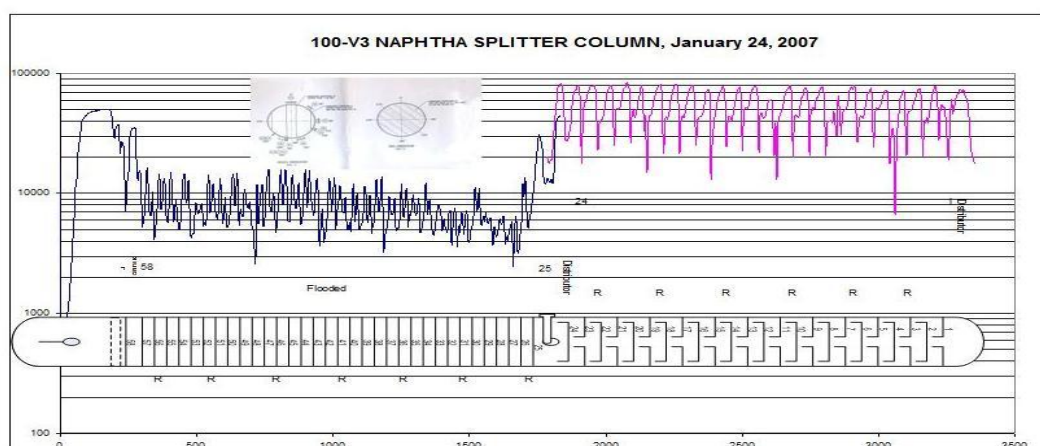
| DATE | VESSELS | No | Remarks |
|---|---|---|---|
| 22-24 Jan 07 | 100-V3, 100-V5, 100-V7 | 3 | 100-V3 Flooding tray 25-57. Trays 1-24 light foaming. 100-V5 flooding trays 53-58. 100-V7 flooding trays 4-5. |

Figure 5 Flooding in the lower section of 100-V3 Naphtha Splitter observed in January 2007

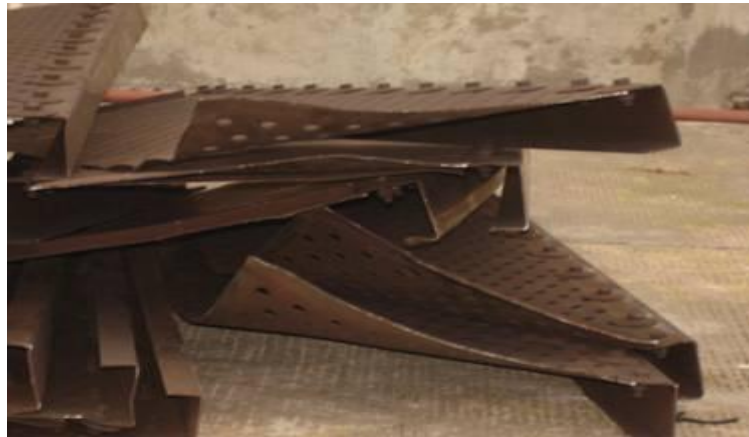
The 433-V4 Toluene Column was constructed under the debottlenecking project and first base line inspected in June 2004. The tower showed good performance of well defined trays with froth loading and clear vapor separation between each adjacent tray as shown in figure 7. In June 2008 the tower experienced partial damage of trays 45-60 in the lower section in which the trays could not hold sufficient amount of froth/liquid as shown in figure 8. Up on visual inspection during maintenance shutdown in November 2008, those trays collapsed down to the bottom of the tower when there was more upward pressure from the gas stream. Pictures of the damaged trays are presented in figure 9.

| DATE | VESSELS | No | Remarks |
|---|---|---|---|
| 2-5 June 08 | 200-V7, 433-V4 | 2 | 200-V7 normal, 433-V4 trays 45-60 partial damaged |

Figure 9 Damaged trays of the 433-V4 Toluene Column

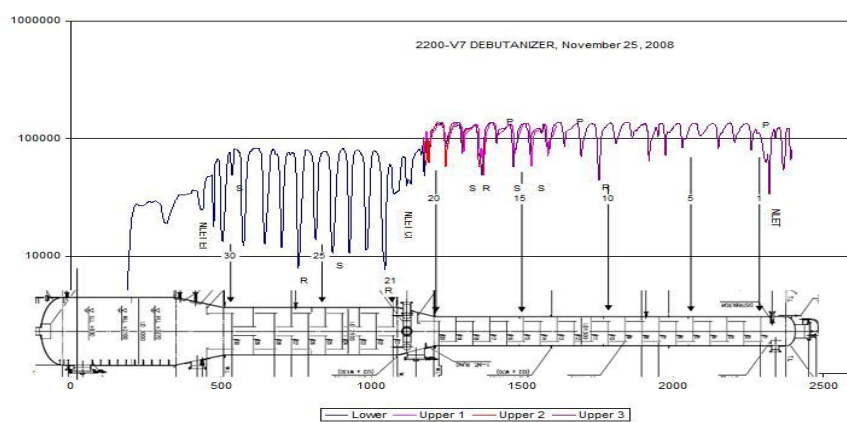
The 2200-V7 Debutanizer comprises in the upper section, the special design trays namely “Advanced Dispersion Valve Tray (ADV tray)” with bubbling promoter to create very fine and homogeneous dispersed froth across the tray (figure 9). Very low froth/liquid loading on trays similar to partial damaged in the upper section was observed in the first inspection in November 2008 as shown in figure 10. It was doubted that the froth on tray might be too fine and too light to be absorbed by the high energy gamma ray of Co-60, so that the tray definition was not clearly indentified. In the next inspection in April 2009, low energy gamma source from 50mCi Cs-137 was

Figure 11 Scanning of ADV trays of 2200-V7 Debutanizer by Co-60 high energy gamma

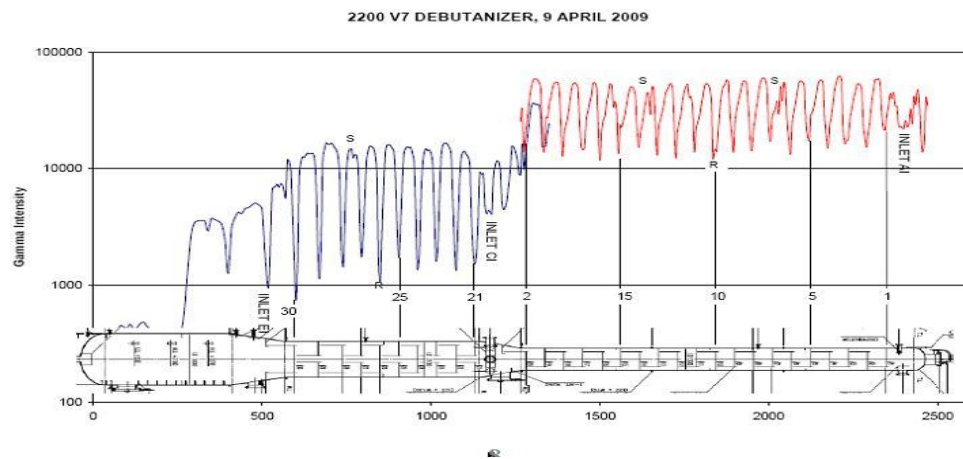
used and better results of well defined trays in the entire column was observed as shown in figure 11. Conclusion could be made that the low energy gamma source of Cs-137 was more suitable for this special designed tray than the high gamma source of Co-60.

Figure 12 Scanning of ADV trays of 2200-V7 Debutanizer by Cs137 low energy gamma
