## ET10: การวิเคราะห์สภาวะการผลิตของหอกลั่นสารอะโรมาติกส์ ด้วยเทคนิคการส่งผ่านรังสีแกมมา

## GAMMA TRANSMISSION TECHNIQUE TO INVESTIGATE THE AROMATICS DISTILLATION PROCESSES.

In the technical Cooperation between PTTAR and TINT during 2007-2009, problem shooting process investigation of the 34 Aromatics production units, mainly distillation columns, was conducted by gamma transmission technique during plant on-line production. In common practice, a collimated 50mCi Cobalt-60 gamma radiation source and a collimated NaI (TI) scintillation detector were set at the same horizontally alignment, opposite and along side the vessel and were then simultaneously vertically moved to several selected elevations. Transmitted gamma intensity penetrating through the vessel at each elevation was recorded and was plotted against the elevation. In comparison with engineering drawing of the vessel, status of process behavior and/or physical abnormality of internals such as foaming, flooding, blockage, damaged etc. could be indentified. This nuclear technology has been recognized as one of the powerful tools for management and planning of production and preventive maintenance program.

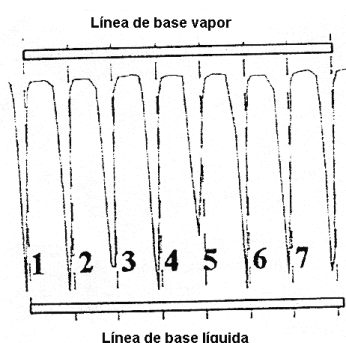
1 – Scanning profile of a normally operating distillation column

Scanning line is perfect and does not cross the jet channels. Between the trays, the intensity is the same as of vapor line. No anomaly is shown besides the tray 5 which is not identical with the other trays. This difference is not significant to identify an anomaly which could stop the column. This difference in intensity can be caused by external obstacles. The liquid level is almost the same in each tray.

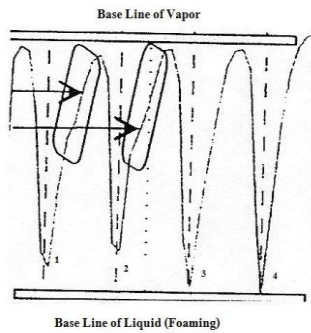
## 2 – Gamma scanning of a column sector with foaming.

A slight foaming appears on the two identical trays of the scan profile. The slope change appears just above the tray. There is no liquid entrainment or obstructions because there is no deviation from the vapor base line.

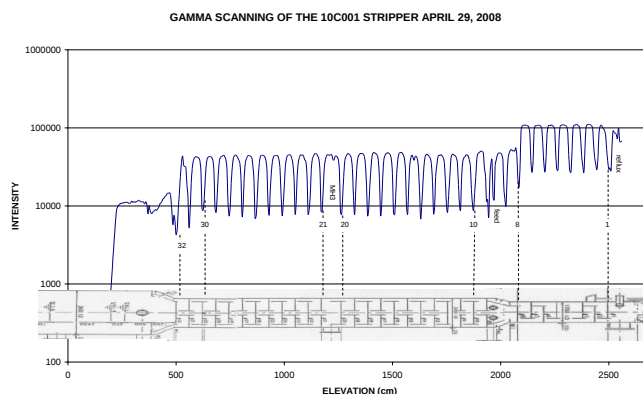
Figure 3: An example scanning result of normal operating column

Typical intensity-elevation profile of normal operating column is shown in figure 3.

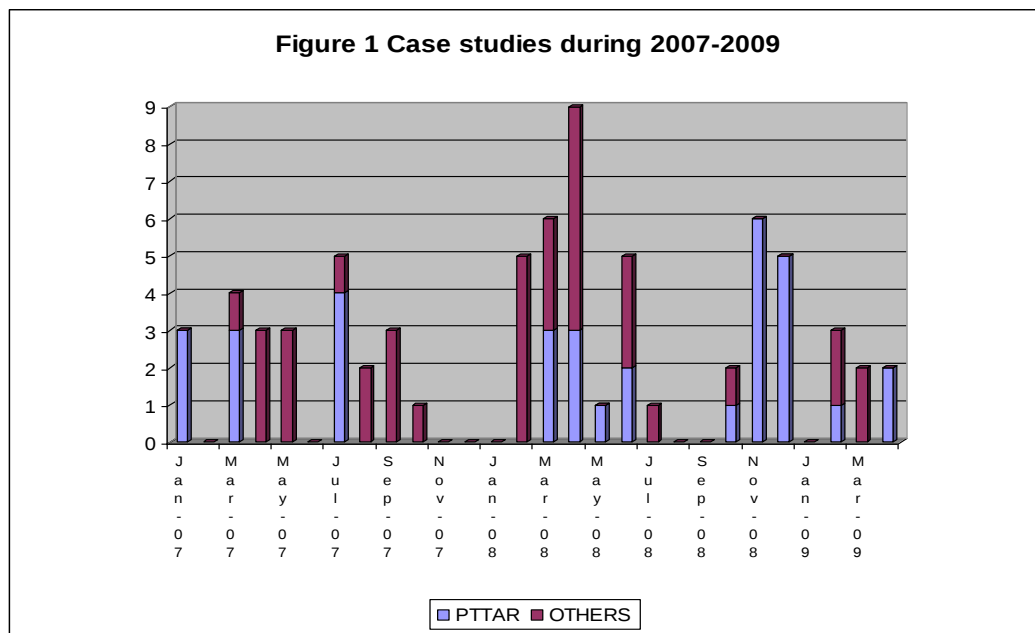
During 2007-2009, totally 72 process vessels of 5 petroleum refineries and petrochemical plants were inspected by gamma transmission technique (see figure 1). There were 34 cases Studies of Aromatics distillation of process vessels of PTTAR as described in table 1 in which 22 vessels were found normal while 17 vessels had some operational and physical problems such as less liquid retention on tray, foaming, flooding, and tray damage. Some vessels of high potential problems were selected for regularly investigation. For example, the 100-V3 Naphtha Splitter, the vessel was

Figure 1 Gamma Scanning Records in the Petroleum & Petrochemical Industries during 2007-2009

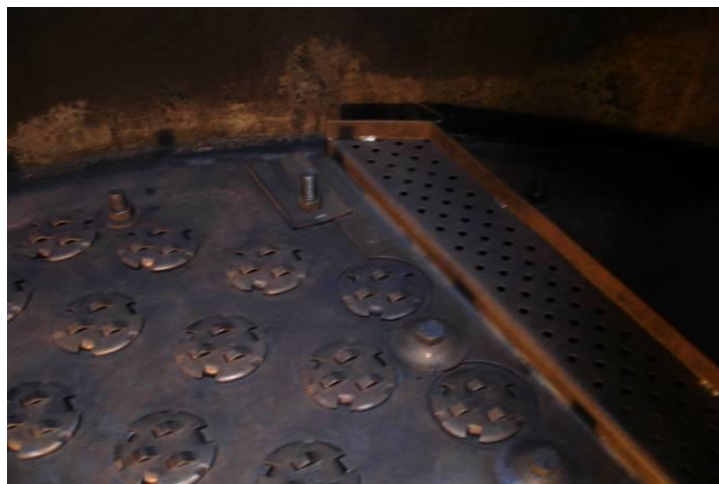
The 2200-V7 Debutanizer comprises in the upper section, the special design trays namely “Advanced Dispersion Valve Tray (ADV tray)” with bubbling promoter to create very fine and homogeneous dispersed froth across the tray (figure 9). Very low froth/liquid loading on trays similar to partial damaged in the upper section was observed in the first inspection in November 2008 as shown in figure 10. It was doubted that the froth on tray might be too fine and too light to be absorbed by the high energy gamma ray of Co-60, so that the tray definition was not clearly indentified. In the next inspection in April 2009, low energy gamma source from 50mCi Cs-137 was

Figure 10 Advanced Dispersion Valve Tray with bubbling promoter
